Subject: Request for Construction Closure of Roxborough Park Road

STERLING RANCH DEVELOPMENT
 DAILY COUNTS ON ROXBOROUGH PARK ROAD

STERLING RANCH DEVELOPMENT
DIRECTIONAL COUNTS ON ROXBOROUGH PARK ROAD

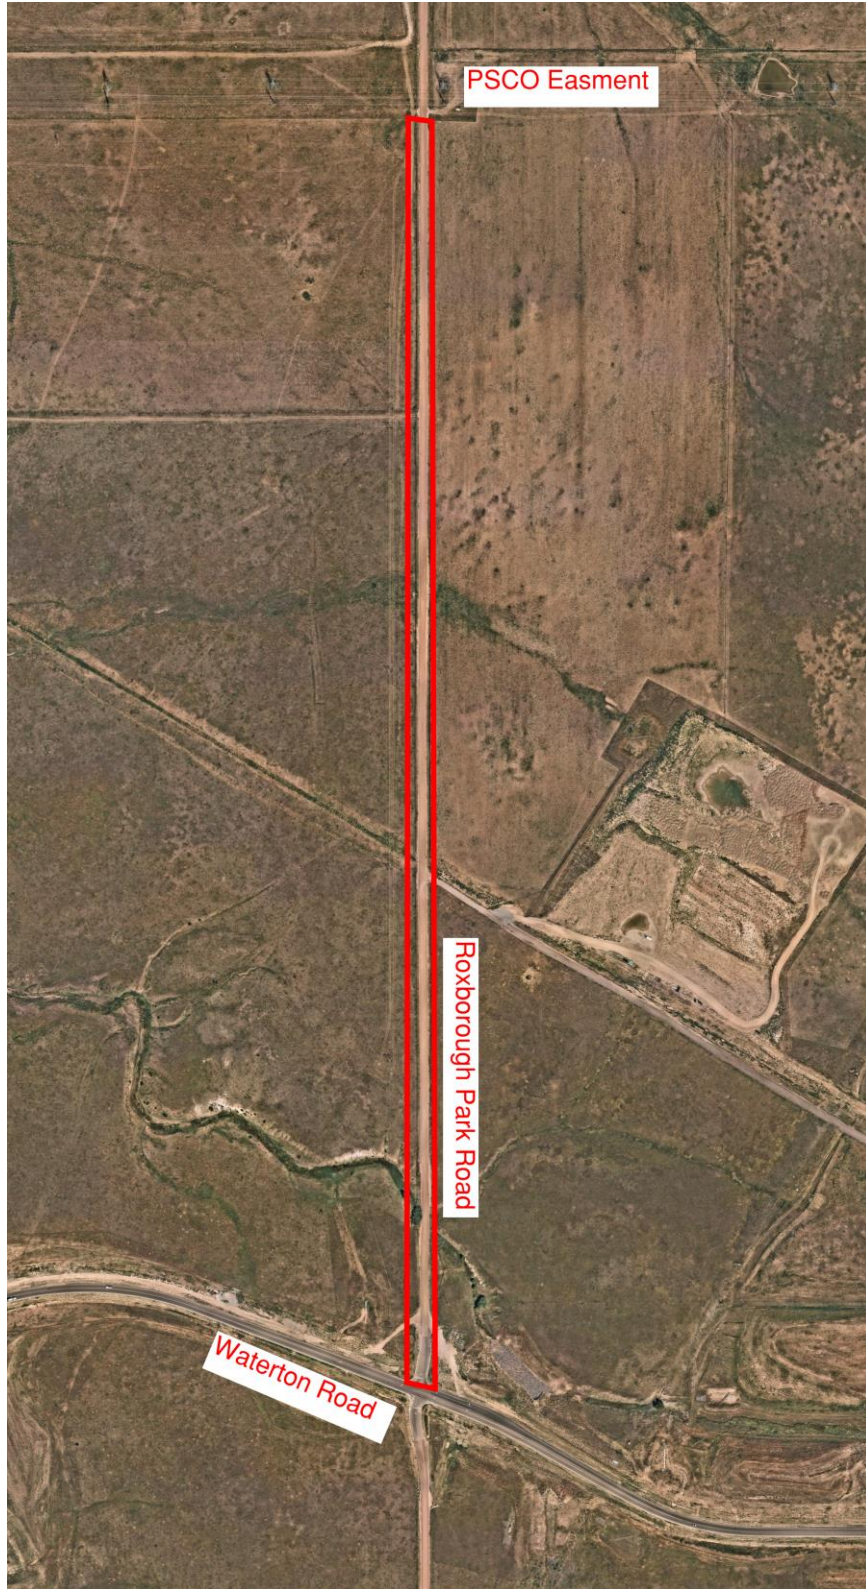
Vicinity Map

A vicinity map graphic has been included on the next page illustrating this area. The extents of this closure will be fronting solely on land owned by Sterling Ranch, LLC. All other users along this vicinity of Roxborough Park Road are north of the PSCO Easement crossing. These users will have more-direct access to Titan Road to the north. Based on the magnitude of these improvements and the minimal traffic utilizing Roxborough Park Road, a construction closure will allow for the safest and most-efficient delivery of these upgrades.

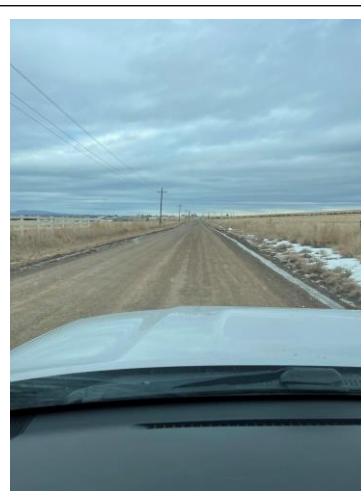
Roxborough Park Road

*pictures taken during count period

South of Xcel Electric Lines			
Day	Light Vehicles	Heavy + Construction Vehicles	Total
1	149	23	172
2	119	31	150
3	116	19	135
<i>Average</i>	<i>128</i>	<i>24</i>	<i>152</i>

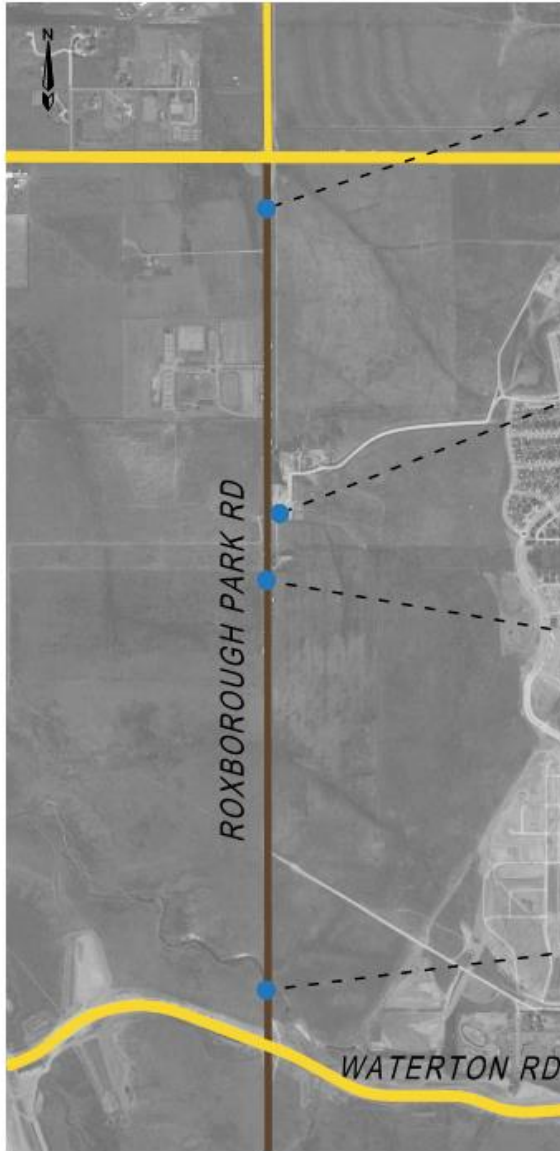
South of Titan Road			
Day	Light Vehicles	Heavy + Construction Vehicles	Total
1	165	27	192
2	144	24	168
3	152	22	174
<i>Average</i>	<i>154</i>	<i>24</i>	<i>178</i>

On CAB Driveway			
Day	Light Vehicles	Heavy + Construction Vehicles	Total
1	72	25	97
2	58	17	75
3	70	18	88
<i>Average</i>	<i>67</i>	<i>20</i>	<i>87</i>

South of Xcel Electric Lines			
Day	Light Vehicles	Heavy + Construction Vehicles	Total
1	149	23	172
2	119	31	150
3	116	19	135
<i>Average</i>	<i>128</i>	<i>24</i>	<i>152</i>

North of Waterton Road			
Day	Light Vehicles	Heavy + Construction Vehicles	Total
1	151	32	183
2	118	32	150
3	124	20	144
<i>Average</i>	<i>131</i>	<i>28</i>	<i>159</i>

Highest Volume Day:
Day 1: Wed. January 17, 2024

The data indicates that daily volumes are very low from an overall standpoint: Upon further interpretation, it can be inferred that construction vehicles and CAB traffic account for approximately 50%-60% of these volumes.

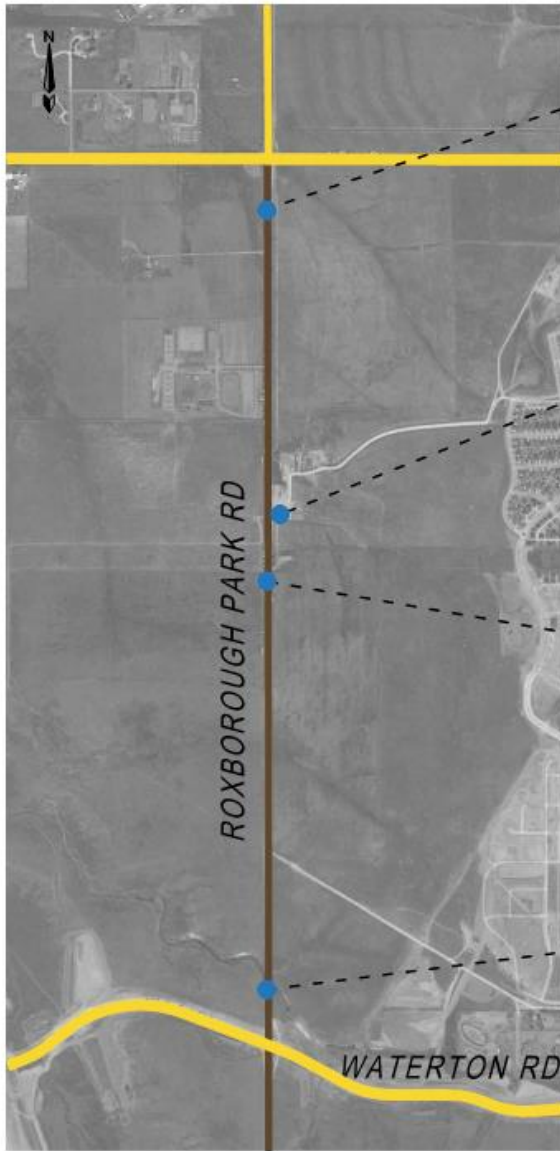
South of Titan Road						
Time	Light Vehicles		Heavy + Construction Vehicles		Total	
	NB	SB	NB	SB	NB	SB
Daily	79	86	15	12	94	98
AM Peak	5	9	0	3	5	12
PM Peak	12	5	1	1	13	6

On CAB Driveway						
Time	Light Vehicles		Heavy + Construction Vehicles		Total	
	EB	WB	EB	WB	EB	WB
Daily	37	35	12	13	49	48
AM Peak	5	6	2	6	7	2
PM Peak	2	4	2	0	4	4

South of Xcel Electric Lines						
Time	Light Vehicles		Heavy + Construction Vehicles		Total	
	NB	SB	NB	SB	NB	SB
Daily	73	76	11	12	84	88
AM Peak	8	11	1	2	9	13
PM Peak	7	7	1	0	8	7

North of Waterton Road						
Time	Light Vehicles		Heavy + Construction Vehicles		Total	
	NB	SB	NB	SB	NB	SB
Daily	75	76	15	17	90	93
AM Peak	4	7	5	7	9	14
PM Peak	7	7	1	0	8	7
